**Flood Control Project Maintenance
Levee Inspections**

Maintenance Issue Types Only, Levee Inspection Report By Mile - Fall 2018

Reclamation District No. 0307 Lisbon

Waterway	Bank	Unit Miles	Inspection Start/End	Inspector
Unit No. 01 Sacramento River	Right	6.56	10/31/2018 10/31/2018	Luz Dial

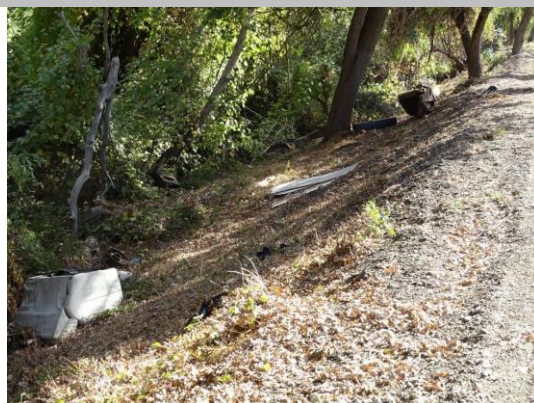
Photo 1 of 2 : FA_2018_RD0307_166_129_20181101_00125.jpg

LM Start	0.14	Rating **	M	Issue No.	129
LM End	0.14	Issue Type +	Ma	Location *	WS
Category	Earthen Levee			GPS Latitude/Longitude	
				Start	End
Item	Encroachments			38.478536 °	38.478536 °
				-121.547707 °	-121.547707 °
DWR ID	DWR_RD0307_01_f_2018_129				
Comment Code					
DE : Debris					
Inspector Comment					
Remove trash from slope.

View of sofa thrown on slope. Fall 2018

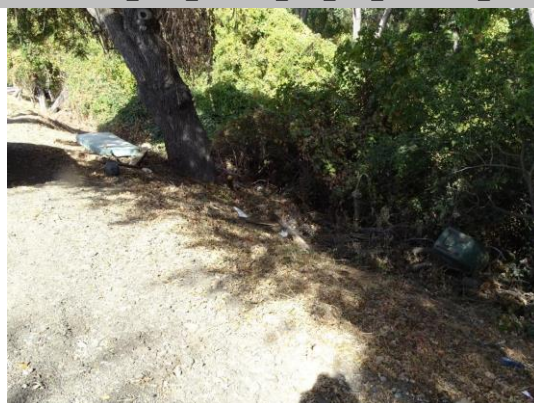
Photo 2 of 2 : FA_2018_RD0307_166_129_20181101_00126.jpg

View of mattress and other debris on slope. Fall 2018

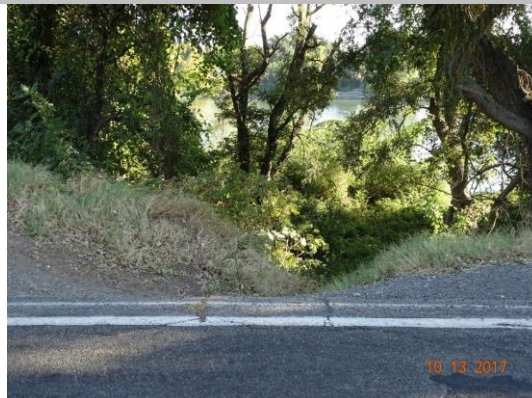
Photo 1 of 1 : FA_2018_RD0307_166_66_20180910_00015.jpg

LM Start	0.20	Rating **	M	Issue No.	66
LM End	0.20	Issue Type +	Ma	Location *	WS
Category	Earthen Levee			GPS Latitude/Longitude	
				Start	End
Item	Slope Stability			38.477977 °	38.477977 °
				-121.546914 °	-121.546914 °
DWR ID	DWR_RD0307_01_f_2017_66				
Comment Code					
S2 : Repair the levee slope damaged by foot traffic and prevent access where possible.					
Inspector Comment					
Foot traffic on waterside slope.

Slope erosion should be repaired and foot traffic stopped.

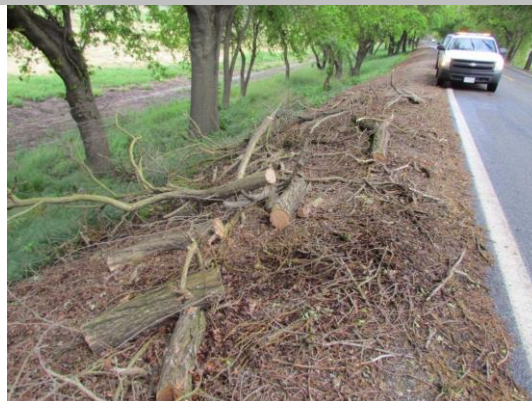
Photo 1 of 1 : FA_2018_RD0307_166_59_20180910_00011.jpg

LM Start	0.35	Rating **	M	Issue No.	59
LM End	0.35	Issue Type +	Ma	Location *	LS
Category	Earthen Levee			GPS Latitude/Longitude	
				Start	End
Item	Encroachments			38.476428 °	38.476428 °
				-121.544955 °	-121.544955 °
DWR ID	DWR_RD0307_01_s_2017_59				
Comment Code					
TR : Tree or limb					
Inspector Comment					
Remove the cut up fallen tree from the landside levee slope and shoulder.

RD 307 Landside slope looking downstream from levee mile 0.35.

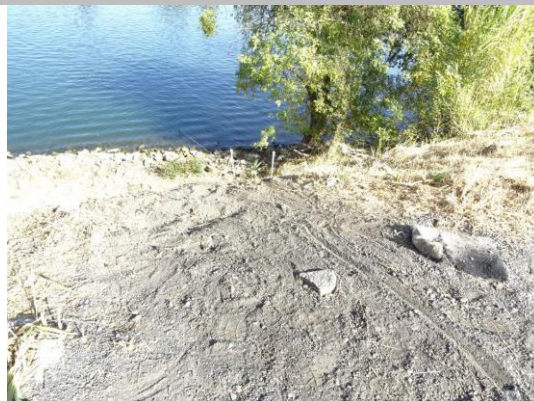
Photo 1 of 2 : FA_2018_RD0307_166_44_20181101_00124.jpg

LM Start	1.14	Rating **	M	Issue No.	44
LM End	1.23	Issue Type +	Ma	Location *	WS
Category	Supplemental			GPS Latitude/Longitude	
				Start	End
Item	2017 USACE Erosion Survey, DRAFT			38.473161 °	38.473103 °
				-121.531474 °	-121.529831 °
DWR ID	DWR_RD0307_01_f_2018_44				
Comment Code					
Inspector Comment					
2017 Site ID: SAC 48.6 R					
Status: Eroding					
2017 Field Notes: Site lengthened upstream and shortened downstream.					
Site History: 2012 - Bank is slowly eroding, old rock protection starting to unravel. 2016 - Anthropogenic erosion observed.

View of erosion on slope. Fall 2018

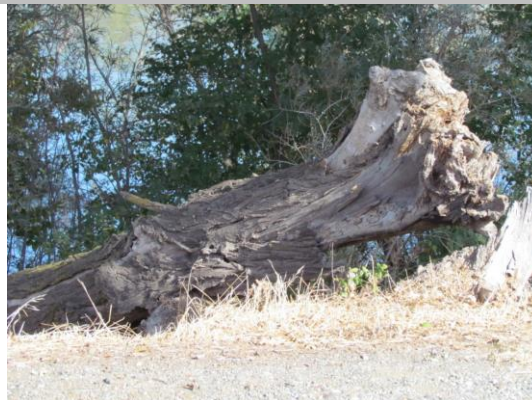
Photo 1 of 1 : FA_2018_RD0307_166_9_20180910_00001.jpg

LM Start	1.29	Rating **	U	Issue No.	9
LM End	1.29	Issue Type +	Ma	Location *	WS
Category	Earthen Levee			GPS Latitude/Longitude	
				Start	End
Item	Encroachments			38.472827 °	38.472827 °
				-121.528785 °	-121.528785 °
DWR ID	DWR_RD0307_01_f_2014_9				
Comment Code					
TR : Tree or limb					
Inspector Comment					
Remove downed trees from waterside slope.

This tree needs to be removed from the waterside slope. Fall 2018

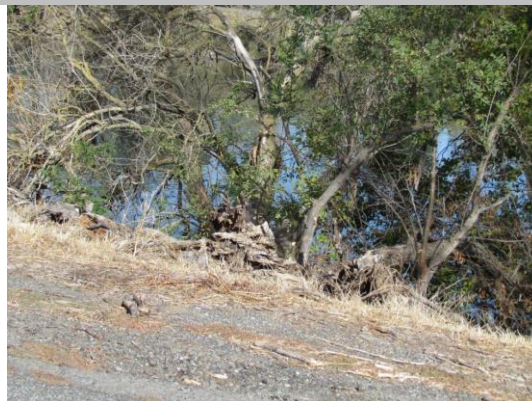
Photo 1 of 1 : FA_2018_RD0307_166_10_20180910_00002.jpg

LM Start	1.35	Rating **	M	Issue No.	10
LM End	1.35	Issue Type +	Ma	Location *	WS
Category	Earthen Levee			GPS Latitude/Longitude	
				Start	End
Item	Encroachments			38.472880 °	38.472880 °
				-121.527733 °	-121.527733 °
DWR ID	DWR_RD0307_01_f_2014_10				
Comment Code					
TR : Tree or limb					
Inspector Comment					
The RD will schedule to have these trees cut up and removed from the waterside levee section as soon as possible. Trees still present during inspection.

Remove unwanted trees from waterside slope. These trees are dead and are resting on the slope. No change 4-17.

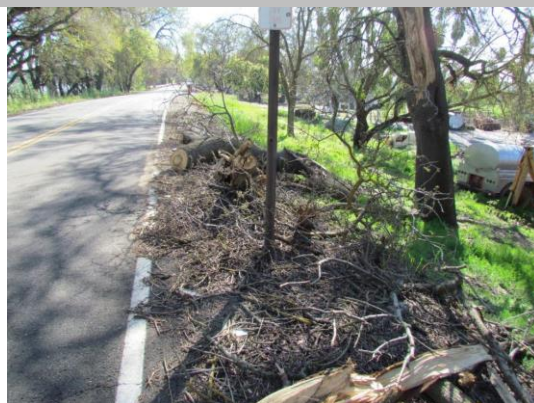
Photo 2 of 3 : FA_2018_RD0307_166_73_20180910_00017.jpg

LM Start	1.86	Rating **	U	Issue No.	73 (cont)	
LM End	1.86	Issue Type +	Ma	Location *	LS	
Category	Earthen Levee			GPS Latitude/Longitude		
				Start		End
Item	Encroachments			38.473182 °	38.473182 °	
				-121.518280 °	-121.518280 °	
DWR ID	DWR_RD0307_01_s_2016_73					
Comment Code						
TR : Tree or limb						
Inspector Comment						
Remove the cut up oak tree from both ls/ws slops the levee section. No change 4-17.

Looking downstream toward levee mile 1.87 fallen tree on shoulder.

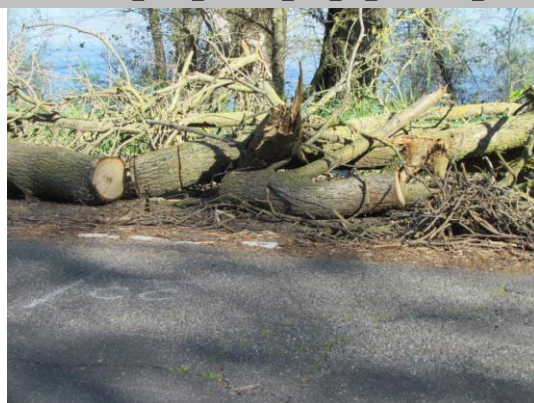
Photo 3 of 3 : FA_2018_RD0307_166_73_20180910_00018.jpg

Waterside shoulder levee mile 1.86 more of the cut up oak.

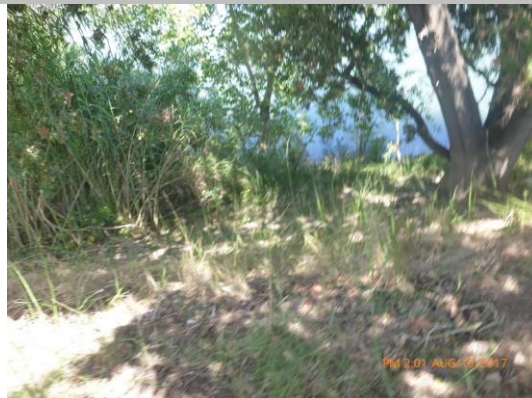
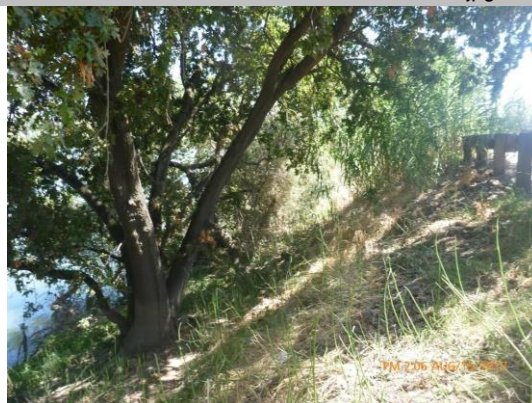
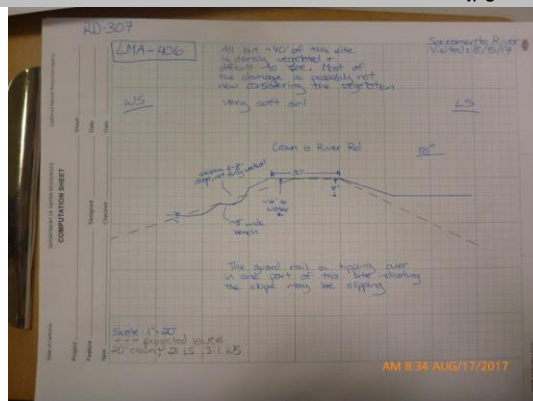
LM Start	2.47	Rating **	M	Issue No.	49							
LM End	2.53	Issue Type +	Ma	Location *								
Category	Supplemental		GPS Latitude/Longitude									
			Start	End								
Item	2017 Storm Damage		38.470583 °	38.470052 °								
			-121.507658 °	-121.506902 °								
DWR ID	DWR_RD0307_01_f_2017_49											
Comment Code												
Inspector Comment												
Levee Evaluation Comments Description: Slope protection repairs are needed along the waterside slope due to erosion and riprap displacement from high water. Based upon levee inspections, it was determined the waterside levee slope is eroding, deteriorating, and degrading. The eroded levee sections need to be restored back to design standards to prevent further deterioration and damage. Site ID No: 500 Site Designation: LMA-406 Repair Type: Erosion Rating: Area of Concern Field Date: 8/15/2017 Notes:

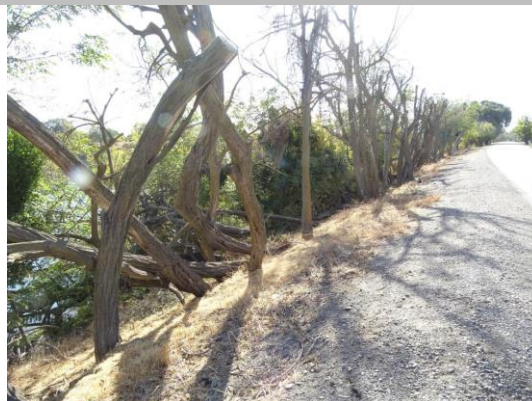
Photo 1 of 1 : FA_2018_RD0307_166_24_20181101_00122.jpg

LM Start	3.86	Rating **	M	Issue No.	24
LM End	3.86	Issue Type +	Ma	Location *	WS
Category	Earthen Levee			GPS Latitude/Longitude	
				Start	End
Item	Encroachments			38.451123 °	38.451123 °
				-121.502622 °	-121.502622 °
DWR ID	DWR_RD0307_01_f_2014_24				
Comment Code					
TR : Tree or limb					
Inspector Comment					
Remove the cut tree limbs from the waterside shoulder.

View of tree limbs on levee slope. Fall 2018

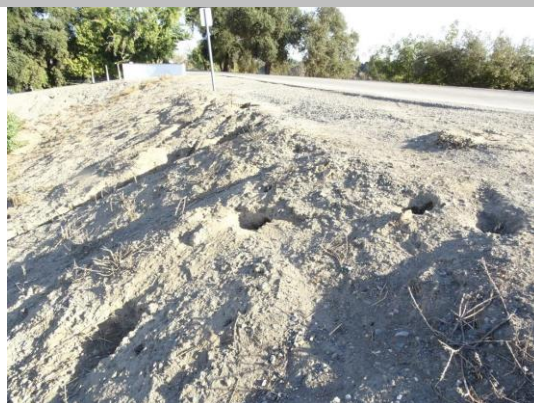
Photo 1 of 1 : FA_2018_RD0307_166_111_20181101_00117.jpg

View of rodent holes on landside slope. Fall 2018

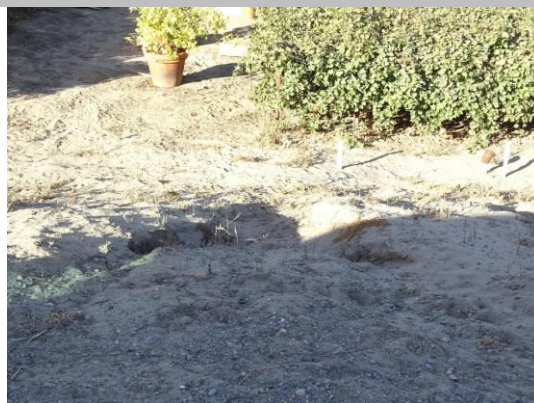
Photo 1 of 3 : FA_2018_RD0307_166_128_20181101_00118.jpg

View of erosion on slope. Fall 2018

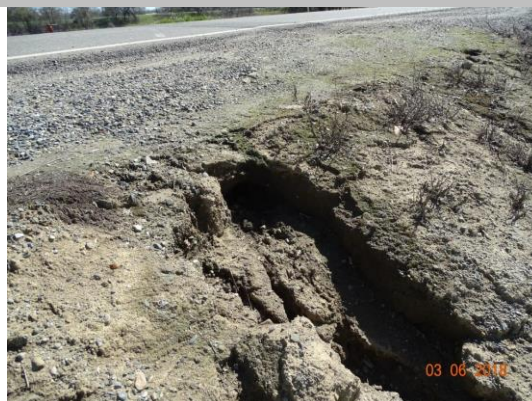
Photo 2 of 3 : FA_2018_RD0307_166_128_20180910_00034.jpg

LM Start	3.98	Rating **	M	Issue No.	128 (cont)	
LM End	3.98	Issue Type +	Ma	Location *	LS	
Category	Earthen Levee			GPS Latitude/Longitude		
				Start		End
Item	Erosion / Bank Caving			38.449404 °	38.449404 °	
				-121.502663 °	-121.502663 °	
DWR ID	DWR_RD0307_01_s_2018_128					
Comment Code						
E1 : Note and monitor erosion site.						
Inspector Comment						
Repair rills on landside slope. Additionally repair rodent holes along this stretch.

Erosion rodent hole landside looking east. Spring 2018

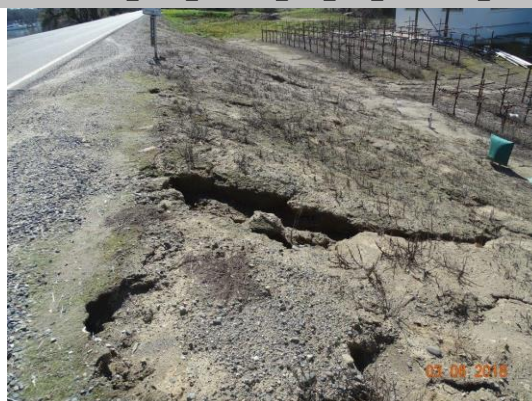
Photo 3 of 3 : FA_2018_RD0307_166_128_20180910_00035.jpg

Erosion rodent hole landside looking south. Spring 2018

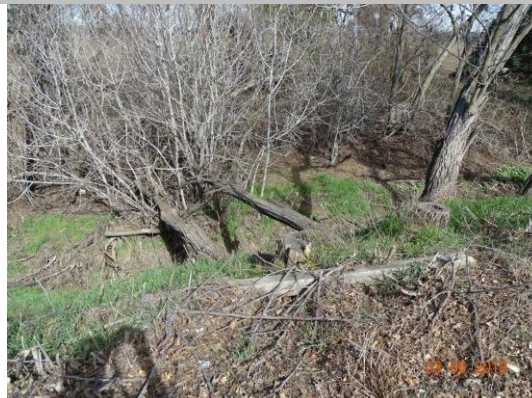
Photo 1 of 1 : FA_2018_RD0307_166_104_20180910_00027.jpg

LM Start	4.88	Rating **	M	Issue No.	104
LM End	4.88	Issue Type +	Ma	Location *	LS
Category	Earthen Levee			GPS Latitude/Longitude	
				Start	End
Item	Encroachments			38.437871 °	38.437871 °
				-121.508356 °	-121.508356 °
DWR ID	DWR_RD0307_01_s_2018_104				
Comment Code					
TR : Tree or limb					
Inspector Comment					
Downed tree on landside slope.

Encroachment downed tree on landside looking south

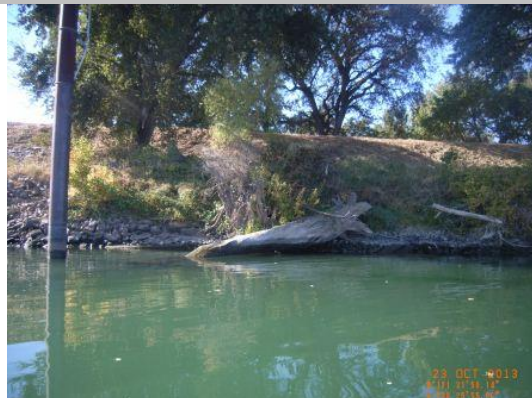
Photo 1 of 1 : FA_2018_RD0307_166_43_20181105_00116.jpg

LM Start	6.19	Rating **	M	Issue No.	43
LM End	6.38	Issue Type +	Ma	Location *	WS
Category	Supplemental			GPS Latitude/Longitude	
				Start	End
Item	2017 USACE Erosion Survey, DRAFT			38.434560 °	38.432287 °
				-121.531159 °	-121.532978 °
DWR ID	DWR_RD0307_01_f_2018_43				
Comment Code					
Inspector Comment					
2017 Site ID: SAC 43.2 R					
Status: Eroding					
2017 Field Notes: New erosion pockets and new toe erosion.					
Site History: 2008 - Large rotational failure in bank and well into the levee slope. Could be a significant problem in the next high flow event.					
2009 - Minimal new erosion, site extended upstream. 2010 - Minor new erosion. 2011 - Tree popout has left a large hole. Large slump area.					
Rock on the bank is failing in some locations. 2012 - The toe appears to be scouring out. 2016 - Some rock placed in the last year

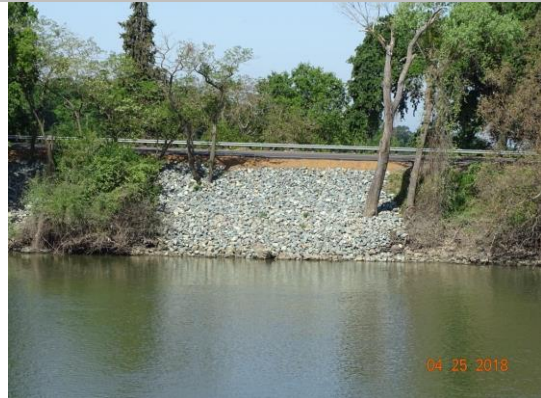
Photo 1 of 2 : FA_2018_RD0307_166_107_20180910_00028.jpg

LM Start	6.42	Rating **	A/W	Issue No.	107
LM End	6.55	Issue Type +	Ma	Location *	WS
Category	Earthen Levee			GPS Latitude/Longitude	
				Start	End
Item	Erosion / Bank Caving			38.431792 °	38.429923 °
				-121.533353 °	-121.533235 °
DWR ID	DWR_RD0307_01_s_2018_107				
Comment Code					
Inspector Comment					
This is to identify corrections to the USACE 2015 Erosion survey. The LMA repaired erosion sites in 2017.

RD307 Lisbon Unit 1 Issue 107 LM6.42-6.55 Erosion repaired picture taken from LB looking west.

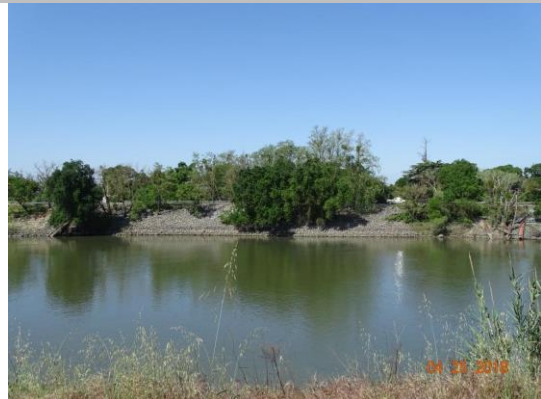
Photo 2 of 2 : FA_2018_RD0307_166_107_20180910_00029.jpg

RD307 Lisbon Unit 1 Issue 107 LM6.42-6.55 Erosion repaired picture taken from LB looking west.

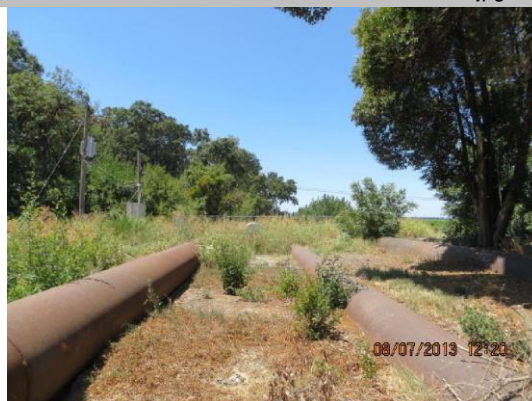
Photo 1 of 3 : UCIP_FA_2018_17406_29510.jpg

Pipes visible on LS toe.

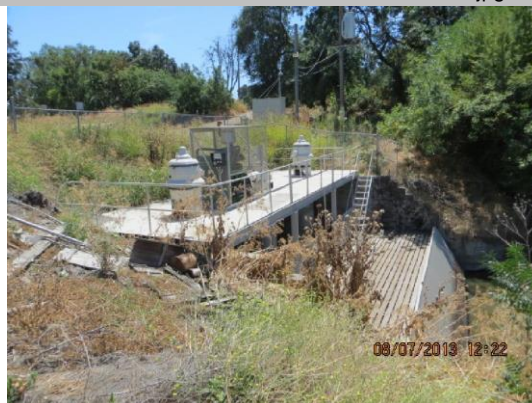
Photo 2 of 3 : UCIP_FA_2018_17406_29509.jpg

Pump and trash rack 200-feet off LS toe.

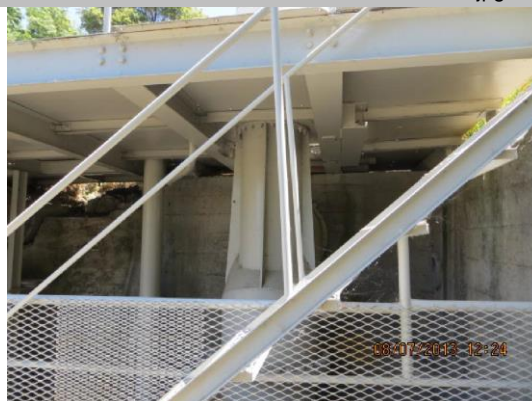
Photo 3 of 3 : UCIP_FA_2018_17406_29508.jpg

Intake at concrete headwall under pump.
